Technical Note 441

EVALUATION OF METHODS FOR PROTECTING BURIED COLD
PIPES FROM EXTERNAL CORROSION AT CHINA LAKE, CALIFORNIA

25 June 1962

U. S. NAVAL CIVIL ENGINEERING LABORATORY
PORT HUENEME, CALIFORNIA

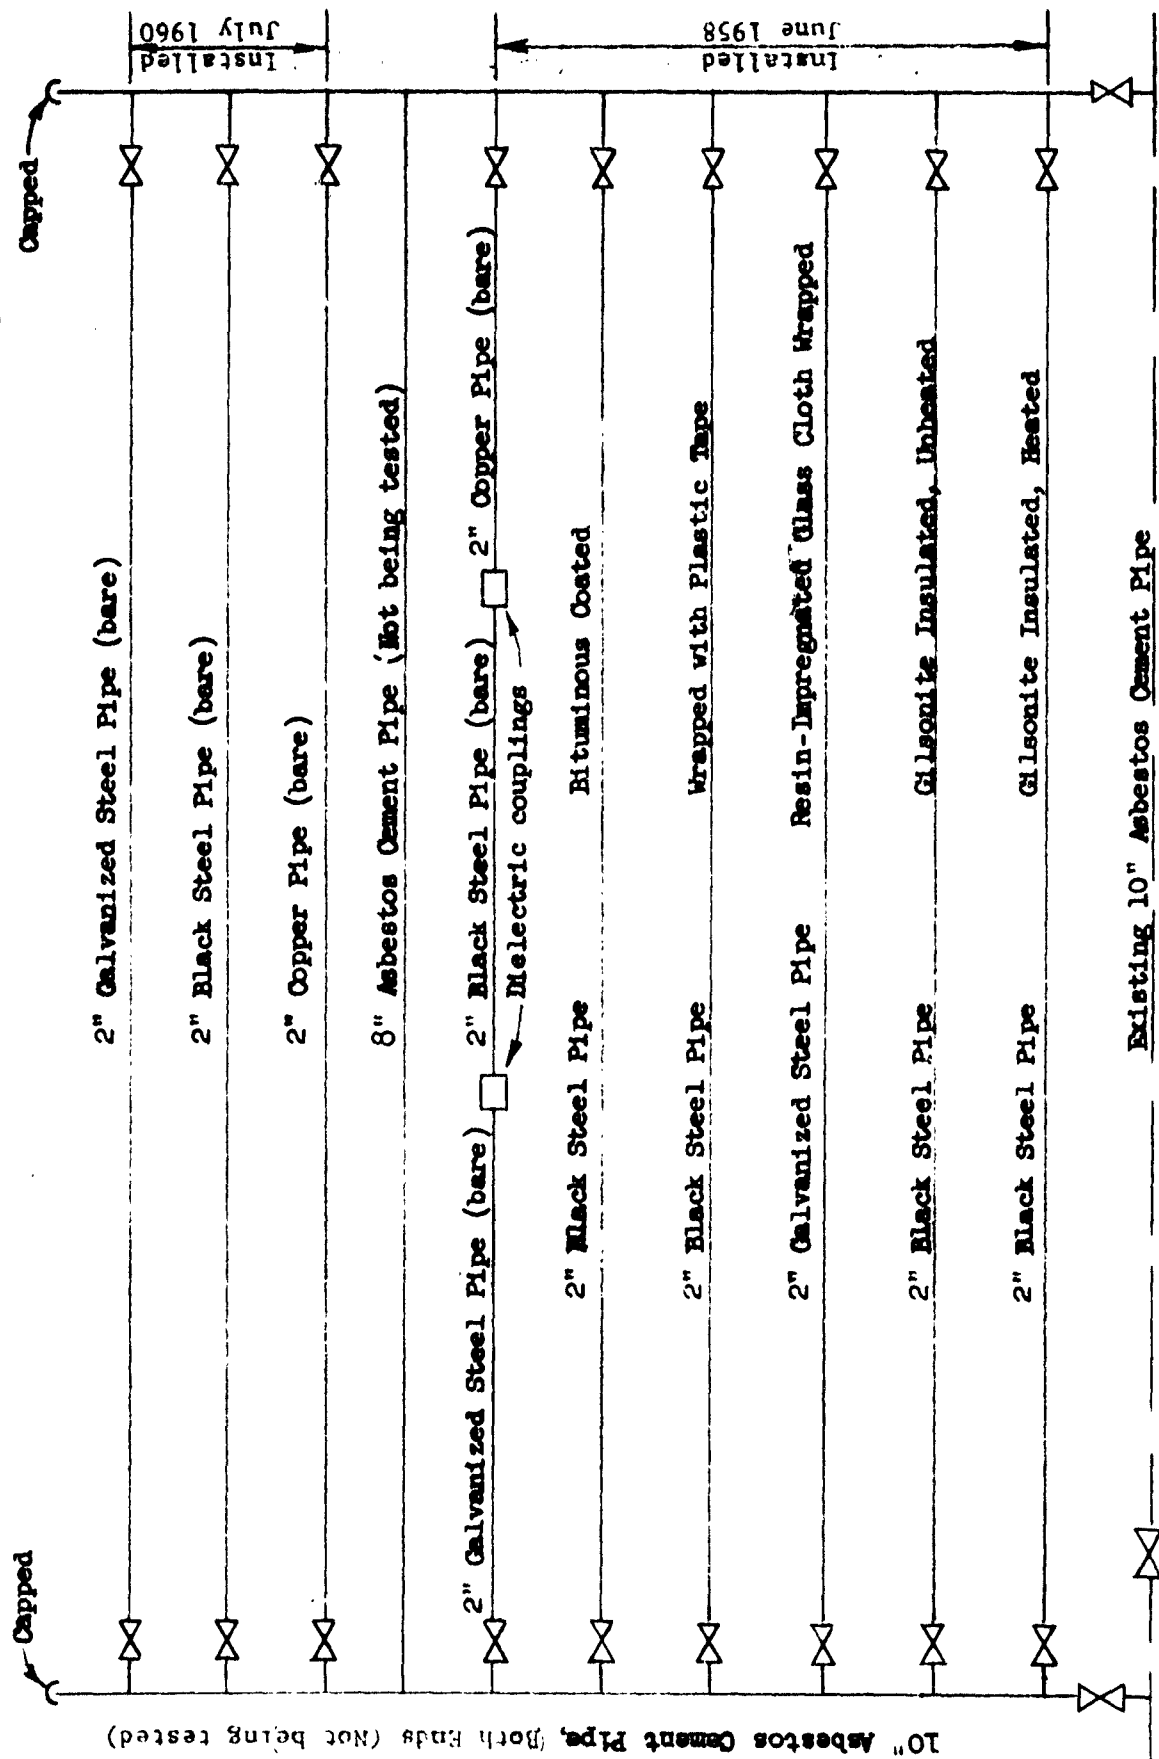
Nine 60-foot sections of both 2-inch bare and 2-inch insulated test pipe were laid in parallel trenches 3 feet deep and spaced 4 feet apart. Three sections are bare. One of these sections is galvanized steel, the second is black steel, and the third is copper. A fourth mixed-pipe section is also bare and consists of 20-foot lengths of galvanized steel, black steel, and copper, dielectric coupled to form one 60-foot section. The five remaining sections consist of steel pipe covered by a variety of insulating materials. The test pipes are connected to an existing 10-inch asbestos covered pipe carrying cold water. The connections are shown in Figure 1. The three 60-foot sections of bare pipe were installed in July 1960. The mixed section of bare pipe and the five sections of insulated pipe were installed in June 1958. A detailed description of each section of pipe is as follows:

Figure 1. Diagram of Underground-Pipe Test Installation. Pipes are spaced 4 feet apart and Buried Approximately 3 Feet Deep
